APPENDIX A

Gauge Information

GAUGE PHOTOS Fish Creek

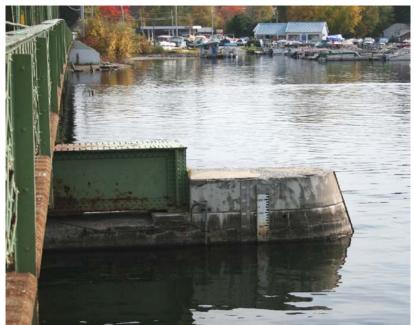
- 1. Route 9P Bridge pier an existing gauge on the upstream end of one of the concrete bridge piers. This gauge provided the extra benefit of being able to access the gauge reading remotely via a telecommunication signal.

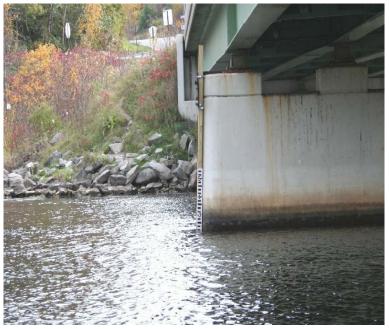
- 2. Stafford's Bridge pier a staff gauge was installed on the downstream side of a concrete bridge pier with the gauge facing north.
- 3. Railroad pile a staff gauge was affixed to a timber piling that supported a former railroad bridge. The gauge was installed to be readable from the north side of the creek. Access to this gauge was cumbersome since there were no public roads that provided access to the gauge site access was down the abandoned railroad property.

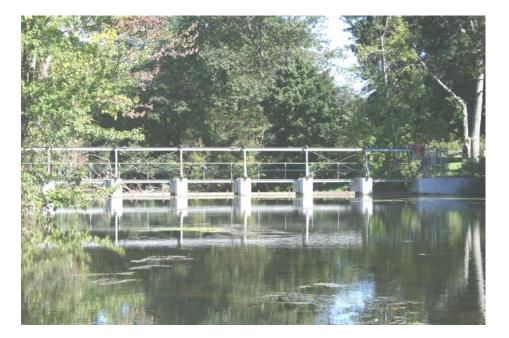
Winnie's Reef - Stop Log Structure.

- 5. Winnie's Reef an existing gauge on the upstream side of the concrete pier at the southern end of the stop log structure. This gauge is visible from the adjoining lawn area to the south.
